STATE OF NEW MEXICO
GOVERNOR'S COMMISSION ON DISABILITY

ACCESSIBLE BARRIER REPORT

WESTERN
NEW MEXICO UNIVERSITY

Inspection Date: 04/19/2019

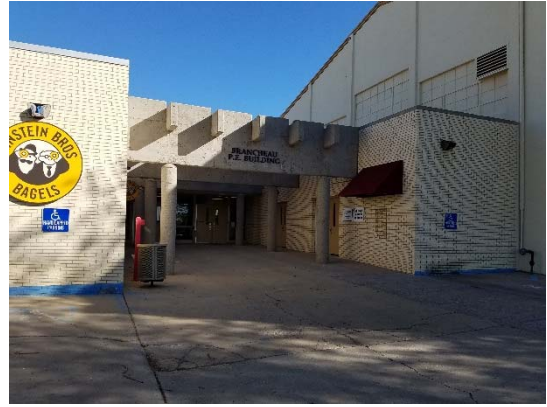
Parking (1) – The designated accessible parking is near the main entrance; however, the existing slope condition exceeds 2.08% (measured 2.8% and 5.7%). Signage needs updated, and no access aisle is provided in striping with the words “No Parking” displayed interior to the striping. We suggest providing a surface that doesn’t exceed 2.08% maximum similar to Figure 1 attached for reference to standard requirements, and re-striping to identify the space and access aisle (per the same required standards). Add International Symbol of Accessibility (ISA) as required at back end of spaces. Incorrect signage is provided (See Figure 2 signage requirements attached), and one space should be designated as Van accessible.

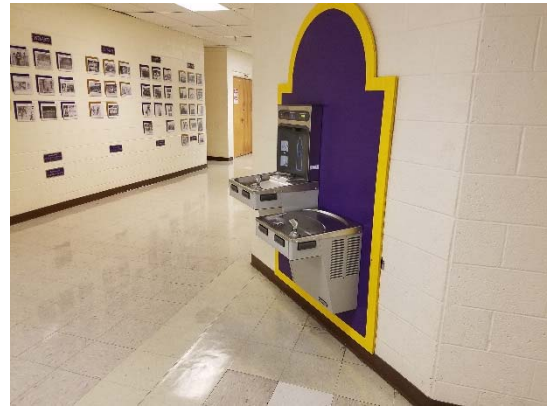
Handball Courts (12) and Intramural Gym (13) - All handball/racquetball courts are provided with a small door entrance that does not allow access to a person with a mobility impairment. At least one court should be modified with an entrance meeting the requirements of Chapter 4 of the ICC A117.1-2009 with reference to clearances, door width and hardware requirements. Doorways into the intramural gym do not provide accessible hardware or door openers to gain access. **(14)** Intramural gym drinking fountains also serve as protruding objects, and are both mounted at standing height, which does not provide the required access for a seated person in a wheelchair.

Weight Room, Locker Rooms and Pool Area – All accessible showers **(15, 16 & 17)** should comply with the technical requirements contained in Chapter 6 of the ICC A117.1-2009 and figures 608.2.1-608.4.3 attached to end of this report (included for easy reference). Barriers identified in men’s locker room: Door opening force was 10#. **(18)** Accessible lavs must insulate pipes to protect against contact. Shower controls not located within range shown on Figure 608.4.2 (measured 50” to operable parts). Grab bar located behind seat, and on partition (verify 250” point load capacity for seat and grab bar. Hooks located above reach range. (We suggest relocating the seat to the solid wall on the opposite side of the stall, lowering at least one hook within reach range and placing the controls appropriately to the relocated seat).

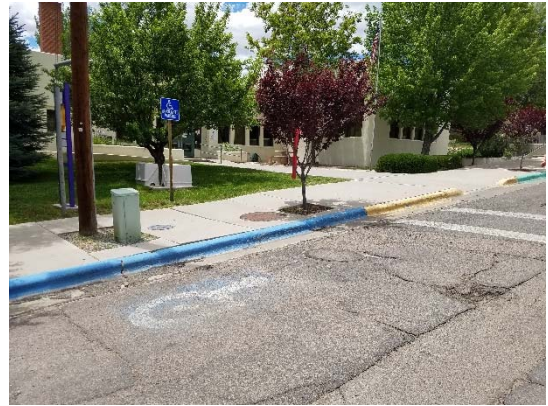
Parking (1) – The existing accessible parking does not comply with current code requirements. The on-street designated accessible parking is close to the main entrance; however the parking surface is not stable, being uneven with a raised manhole, vertical changes in level greater than 1/4", slopes greater than 2.08% (varies from 6 to 8% as measured), no access aisle is provided to curb cut, striping and ISA need repainted and incorrect signage is provided (See Figure 2 signage requirements). One parking space should be designated as Van accessible.

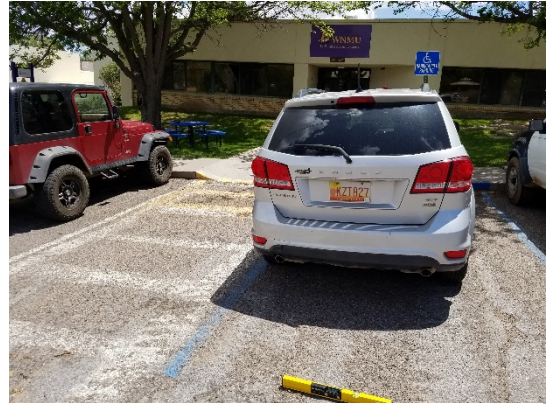
Parking (1) – The designated accessible parking is close to the apparent entrance; however, a sign directs the person down the hill to the Sechler Rhoades Hall for entry. This is confusing to a person with a disabled placard trying to park and enter the building under the designated conditions. We suggest eliminating the identified accessible space and creating an additional accessible parking space closer to the designated public entrance. The existing slopes are greater than 2.08% (varies from 4 to 7% as measured), **(2)** incorrect signage is provided (See Figure 2 signage requirements attached) one accessible parking space should be designated as Van accessible, **(3)** striping and International Symbol of Accessibility (ISA) need to be provided/repainted.

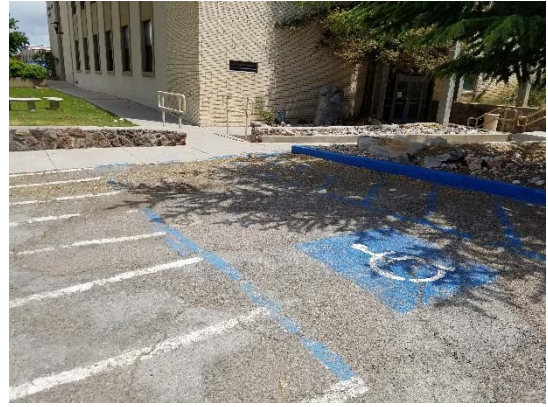
Parking (1) – The designated accessible parking is in close proximity to the main entrance; however, the existing condition of the paving is in disrepair and requires re-grading/paving to eliminate vertical changes in level greater than 1/4” and provide a firm stable surface. There is one space identified for accessible parking with the access aisle against the curb aligned with the sidewalk that crosses the drainage culvert and one ample space on the other side of a loading area for maintenance vehicles. We suggest providing a surface that doesn’t exceed 2.08% maximum slope and is level with the sidewalk, adding curb stops to keep vehicles from diminishing the accessible route, re-striping to provide an additional accessible space by placing one against the curb the sharing an access aisle between the two accessible spaces (see Figure 1 attached), and there should be enough space for a standard maintenance space next to that. Add International Symbol of Accessibility (ISA) as required at back end of accessible parking spaces. **(2)** Incorrect signage is provided (See Figure 2 signage requirements attached), and one parking space should be designated as Van accessible.

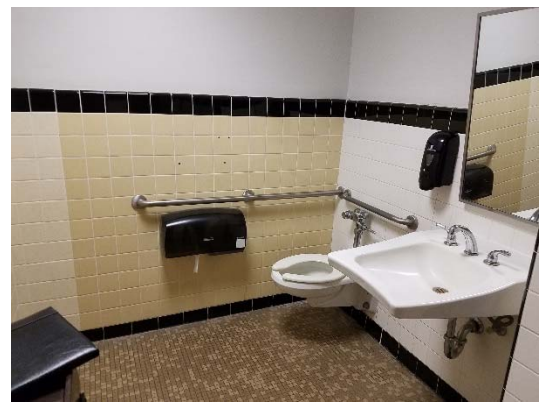
(8)

Bathrooms (7 & 8)- All restrooms (single and multi occupant) should comply with technical requirements contained in Chapter 6 of the ICC A117.1-2009 and figures 604.2-606.3 attached to end of this report (included for easy reference).

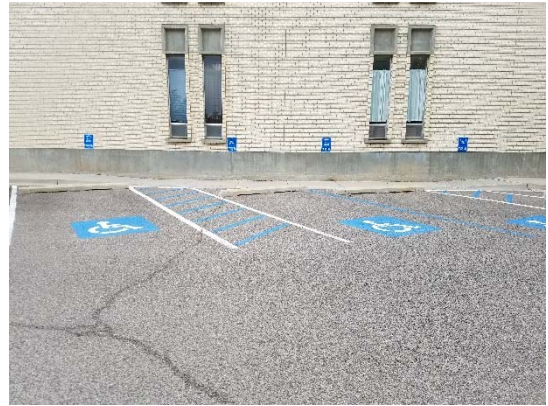
(1)

Parking – The designated accessible parking is near the main entrance; however, the existing slope of the paving exceeds 2.08% maximum slope (3.7% measured) which requires re-grading/paving. We suggest providing a surface that doesn't exceed 2.08%, re-striping and signage provided per requirements of Figure 1 and Figure 2 (see attached), and one parking space minimum shall be designated as Van accessible.

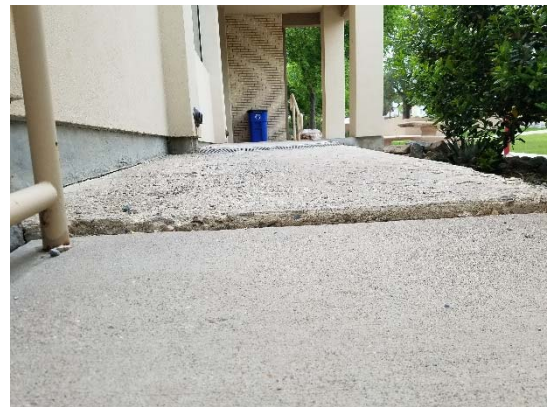
Exterior Accessible Route - The path of travel to the entry doors is compliant, except: (2) the concrete walk from parking to the building exceeds 1/4" vertical (measured 3/4") (per Figure 303.3 attached), there's no edge protection at the 16" drop-off created by the walk modification to the landing (over the original stairs), and the concrete is spalling thereby compromising the firm, stable surface.

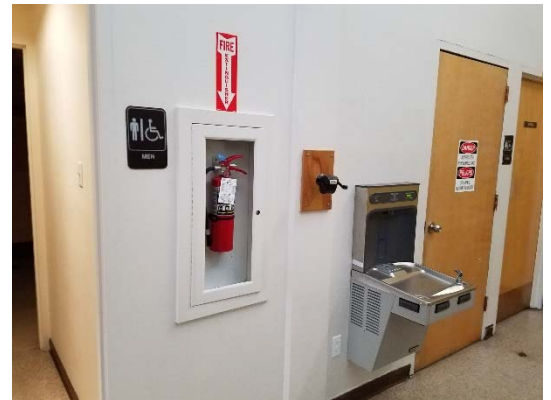
Interior Barriers – (3) Drinking fountain (D/F) provided is single fixture for seated person with no protection for cane detection of people with site impairments. Suggest providing a high/low fixture with guards for cane detection (provide cane detection protection at all D/F). (4 & 5) Various doorways into rooms do not provide required door clearance per Figure 404.3.2.1. Handrail extensions at stairs are not compliant with Figures 505.10.1 & 505.10.2. Interior passage doors with closers require force in excess of 5# to open (9# - 11# measured).

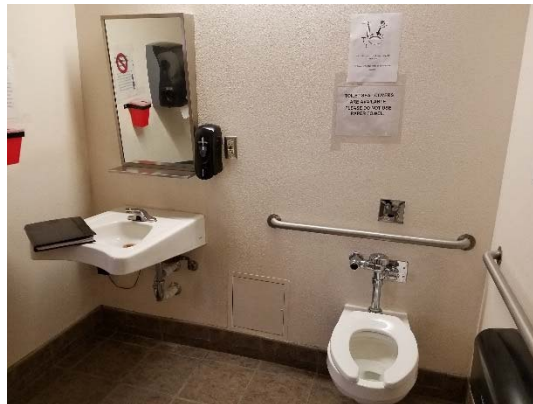
(4)

Bathrooms (4 & 5) - All restrooms (single and multi occupant) should comply with technical requirements in Chapter 6 of the ICC A117.1-2009, figures 604.2-606.3 attached to end of this report are included for easy reference. Items identified as non compliant are: no wheel chair compartments provided in multi occupant rooms with appropriate grab bars and clearances, urinals mounted higher than 17" max to rim, door size does not meet 32" requirement (measured 29"), some door clearances conflict with requirements of Figure 404.3.2.1, reflective surface of mirrors is higher than 40" max requirement for accessible lav, faucet controls require grasping and twisting of the wrist, shelf protrudes into accessible route as well as pipes are not insulated below lavs. Single occupant toilet rooms located on both floors required force in excess of 5# to operate the doors (12# & 13# measured), the mirrors are mounted in excess of 40" A.F.F. and the toilet centerline exceeds the code required range of 16"-18" from the adjacent wall per Figure 604.2 attached (18.5" & 19.5" measured). Pipes are also not insulated below lavs in single occupant restrooms.

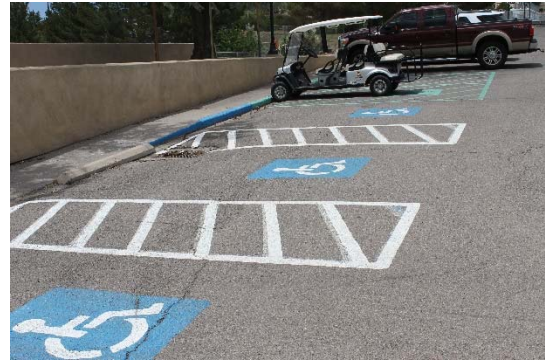
(1)

Exterior Accessible Route - The path of travel to the entry doors is compliant, except that the irregular surface is in need of repair.

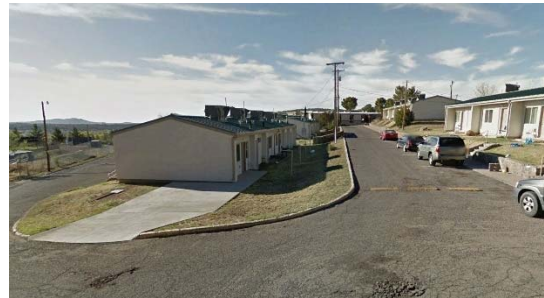
Parking (1) – Private parking is provided near the buildings for the accessible rooms.

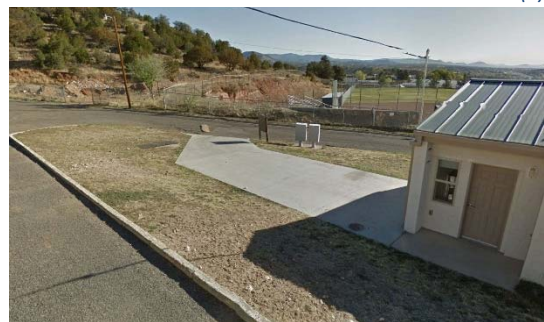
Exterior Accessible Route (2) - The path of travel to the entry doors is compliant, except that maintenance is required to provide a firm, stable and slip resistant surface without obstructions (weeds need to be removed from cracks in sidewalk). Utility access located in the accessible route is not flush with the surface and should be modified to maintain a level surface.

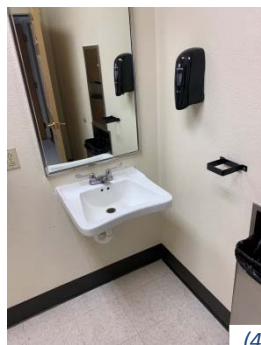
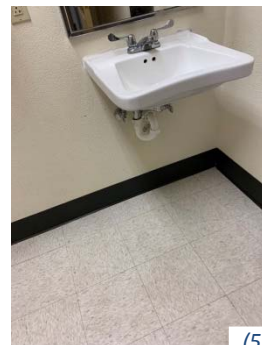
Bathrooms - All restrooms should comply with clearance and plumbing fixture requirements displayed in illustrations at end of this report. Photos (3) and (4) show the soap dispensers mounted at a raised elevation exceeding the maximum 48” allowed. A square metal obstruction exists at sidewall, please remove. Protection against contact with drain pipes and supply lines under lavatory is required. Photo (5) shows no insulation is provided on the drain pipe.

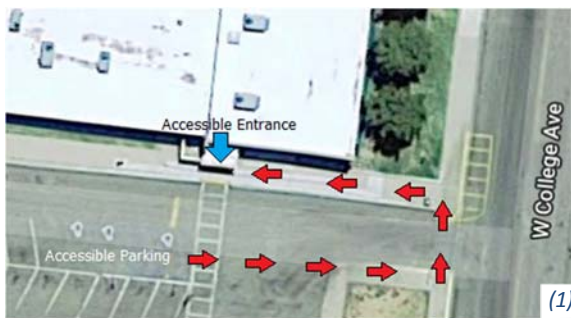
Exterior Accessible Route – Though the accessible parking is in close proximity to the secondary accessible entrance, the accessible route from the parking to the entry requires a person using a mobility aide to travel a much longer distance than an able bodied person to get to the accessible entrance (Photo 1). Recommendation: A raised pedestrian path/ speed deterrent hump, level with the top of the sidewalk, is one example of how direct access to Castorena Hall entrance can be provided from the accessible parking (Photo 2).

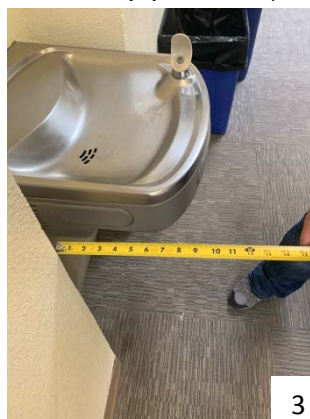
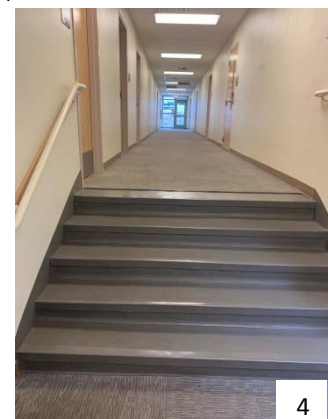
Interior Barriers – Drinking fountain provided is a single fixture for use by seated persons. It is a protruding object with no protection for cane detection by people with visual impairments (Photo 3). Recommendation: provide two fountains - high/low, with wing walls for cane detection. Fountain protrudes from mounting wall beyond the 4” maximum allowed. The President’s office area is elevated. Access to this area is by steps only with no ramp provided (Photo 4). Access to this area must be provided.

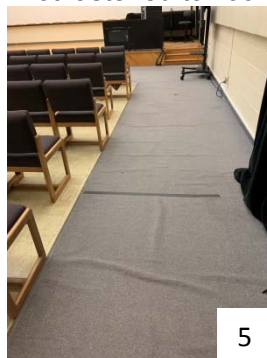
Interior Barriers – Carpet in recital room not fastened to floor surface (Photo 5). It is a tripping hazard.

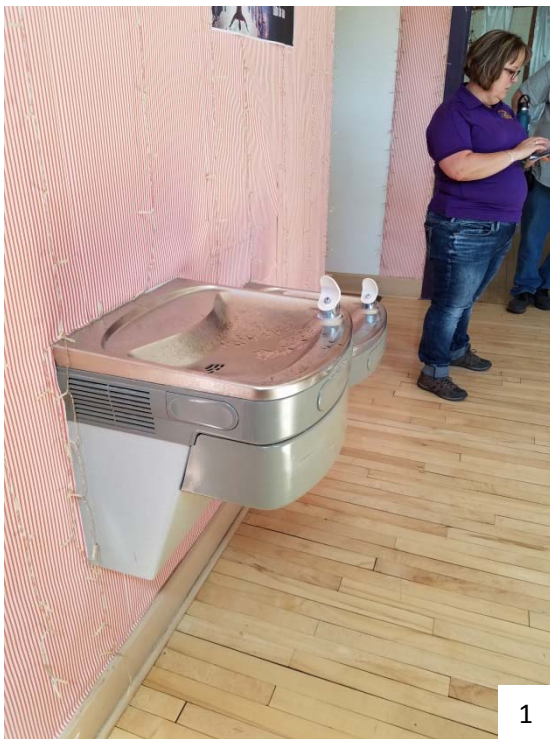
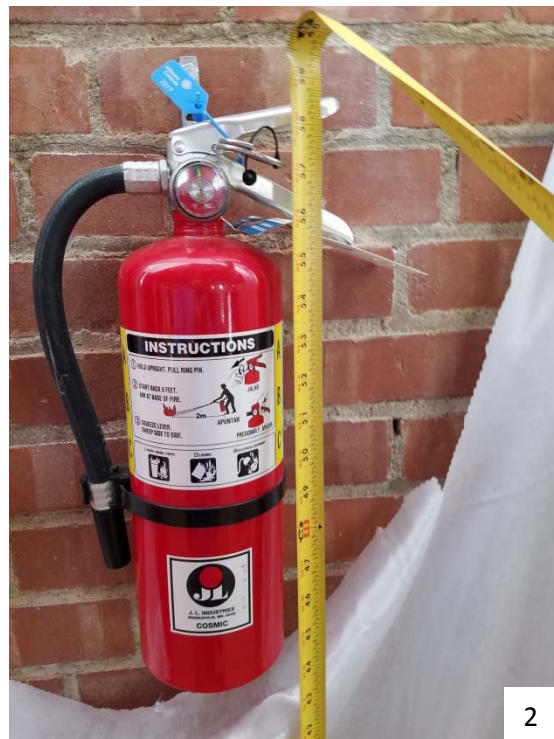
Interior Barriers – Drinking fountains provided have no protection for cane detection by people with visual impairments (Photo 1). Provide some sort of detection (wing walls) where objects protrude more than 4” from the mounting wall. Fire Extinguishers protruded past the maximum allowed 4”, and the handle also exceeds the 48” maximum mounting height allowance (Photo2).

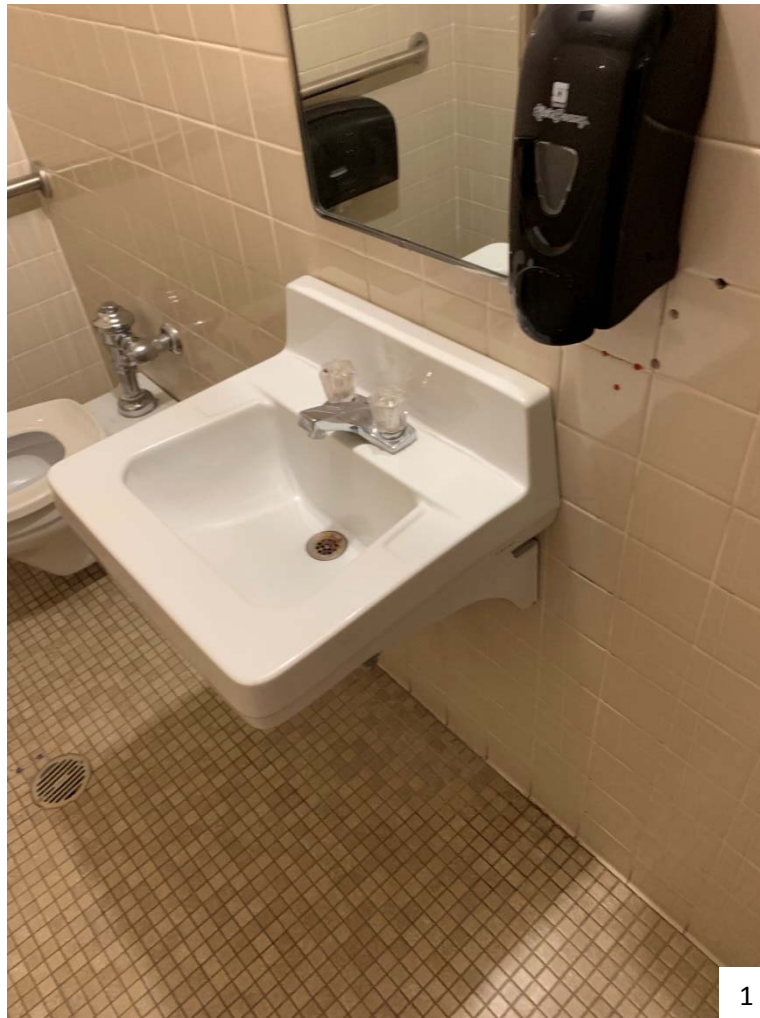
Bathrooms - All restrooms should comply with clearance and plumbing fixture requirements displayed in figures 604-608.4.3 at end of this report. Faucet handles in the ADA restroom need to be replaced with lever type handles that are operable with one hand and shall not require tight grasping, pinching, or twisting of the wrist. There is no rear wall grab bar located behind the toilet in the accessible restroom (Photo 1).

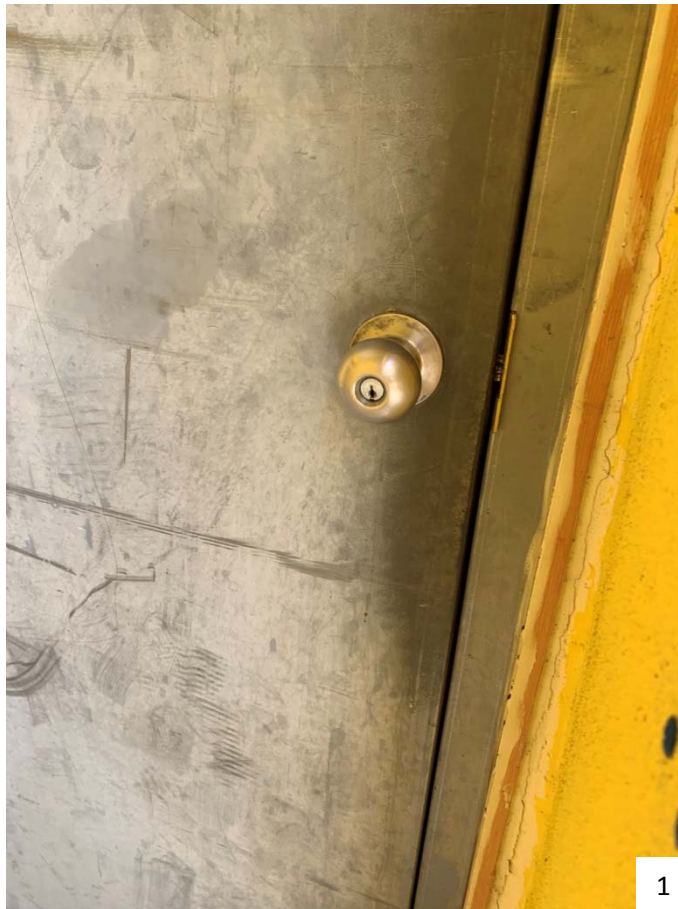
Building Entrance - Entry door on the 1st floor is equipped with round door knobs (Photo 1). These need to be replaced with door handles having parts that are operable with one hand and do not require tight grasping, pinching, or twisting of the wrist to operate.

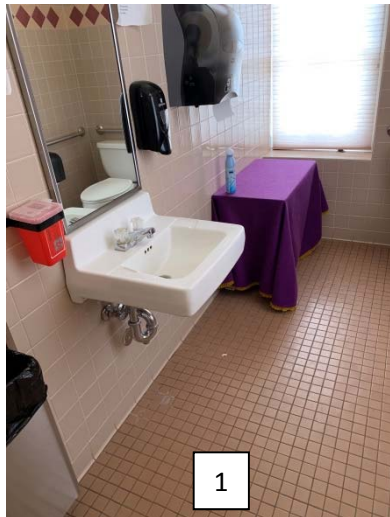
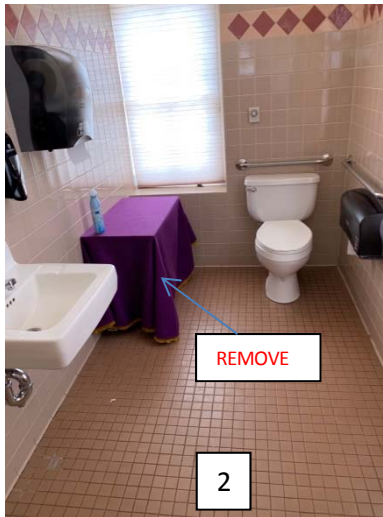
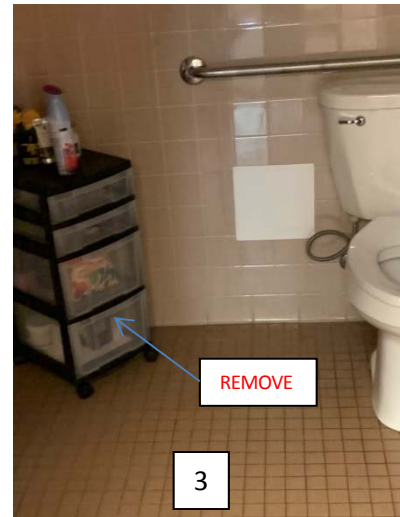
Bathrooms - All restrooms should comply with clearance and plumbing fixture requirements displayed in figures 604-608.4.3 at end of this report. Protection against contact with drain pipes and supply lines under lavatory is required. Photo (1) shows no insulation on the piping. Faucet handles in the ADA restroom need to be replaced with handles that have parts that are operable with one hand and shall not require tight grasping, pinching, or twisting of the wrist (Photo 1). A “changing table” is located in the transfer space in the accessible restroom on the top floor (Photo 2). This area needs to be kept clear. A rolling organizer is located in the transfer space in the bottom floor bathroom (Photo 3). This entire area needs to be kept clear.

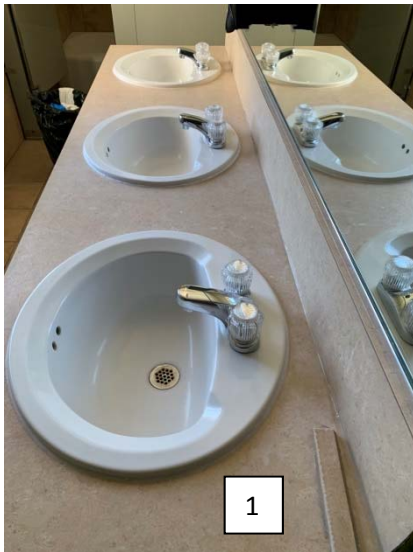
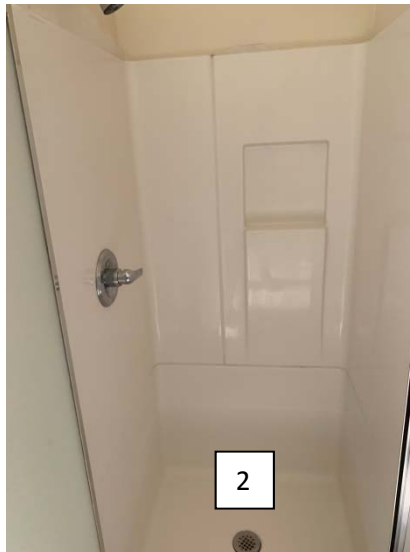
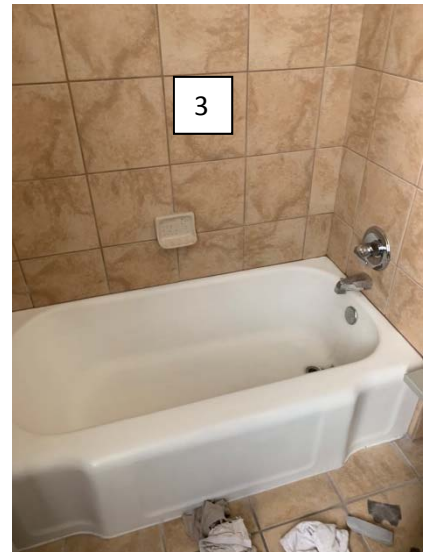
Bathrooms - All restrooms should comply with clearance and plumbing fixture requirements displayed in figures 604-608.4.3 at end of this report. Protection against contact to drain pipes and supply lines under lavatory is required. Faucets in the ADA restroom need to be replaced with lever type handle faucets that are operable with one hand and do not require tight grasping, pinching, or twisting of the wrist to operate (Photo 1). Showers and bathtub in community restrooms on the dormitory floors do not have grab bars (Photo 2 & 3). The restrooms are of the ambulatory type with no wheelchair accessible toilet compartment provided.

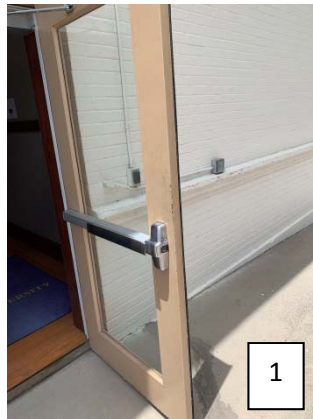
Entry (2) – Access to the School of Business in Light Hall is achieved through the use of an automatic door opener. When activated, the door opens into the path of travel from the activation button to the entry, which makes travel to the open door difficult. The activation button is behind the door when in the open position (Photo 1). Relocation of the activation button to a more suitable location is recommended.

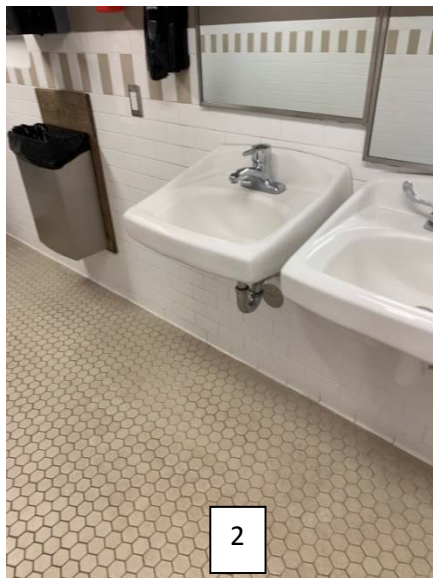
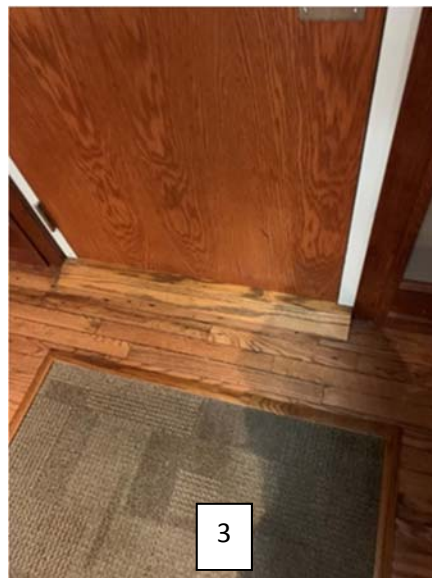
Bathrooms - All restrooms should comply with clearance and plumbing fixture requirements displayed in figures 604-608.4.3 at end of this report. Protection against contact to drain pipes and supply lines under lavatory is required. Photo (2) shows no insulation on the drain pipe. Threshold for the men’s entry door needs contrasting marking, as same colors will give an illusion of no change in grade (Photo 3).

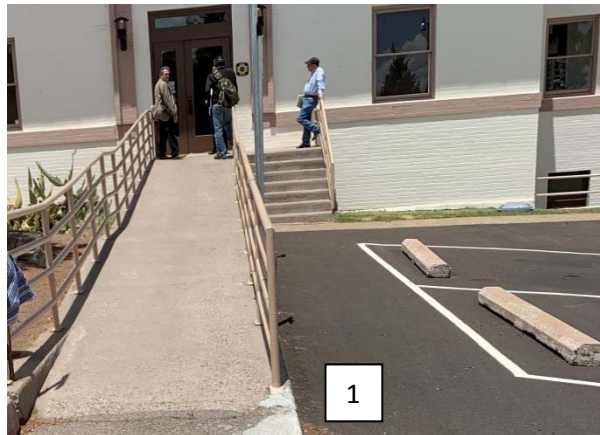
Accessible Route – Access to Fleming Hall from the accessible parking is via a 50 foot ramp with no mid-level landing that is required by code (Photo 1).

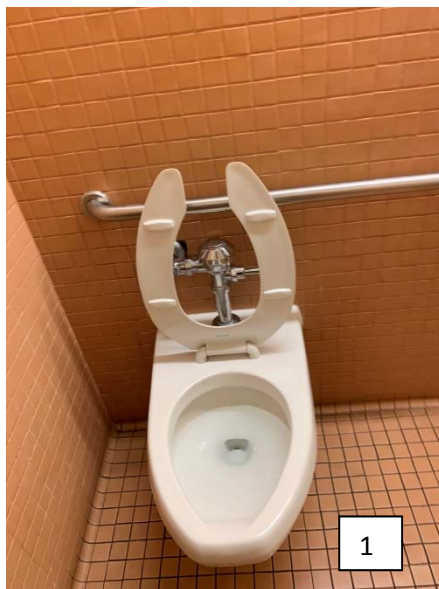
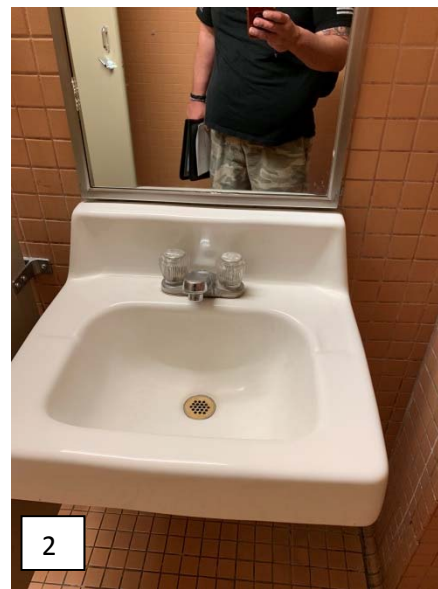
Bathrooms - All restrooms should comply with clearance and plumbing fixture requirements displayed in figures 604-608.4.3 at end of this report. The required horizontal grab bar located on the side wall of the toilet is not provided (Photo1). Faucet handles in the ADA restroom need to be replaced with lever type faucets that are operable with one hand and shall not require tight grasping, pinching, or twisting of the wrist to operate (Photo2).

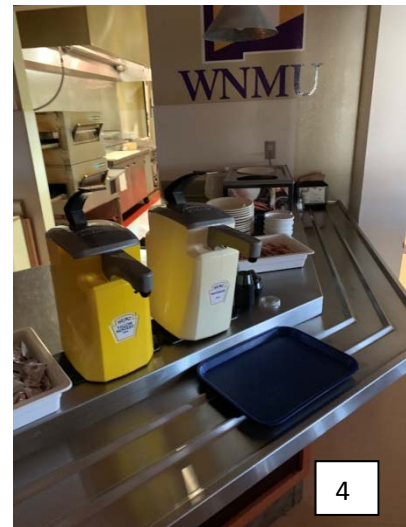
Cafeteria - The area where students scan their card for payment needs to be lowered to where the operable part is lower than 48” (Photo 2). The counters for self-serve items cannot be higher than 36 inches above the floor. Food service items are placed toward the back of the serving counter beyond the maximum depth for a reach range of 10”-24” (Photo 3). While this leaves space for people to set their trays, plates, or beverage containers, this may make items more difficult to reach. Condiments also do not meet this requirement (Photo 4). The operable parts in the coffee and beverage area exceed the maximum 48” high requirement. The operable parts on the coffee and beverage machines are 53” high.

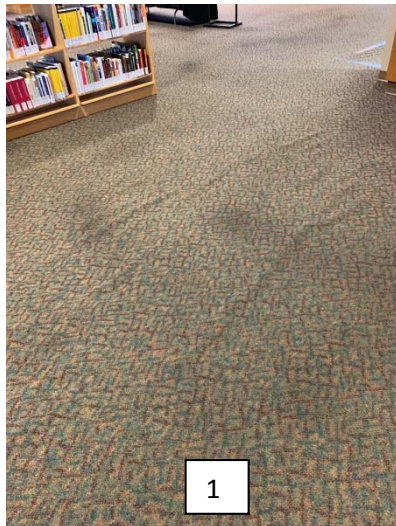
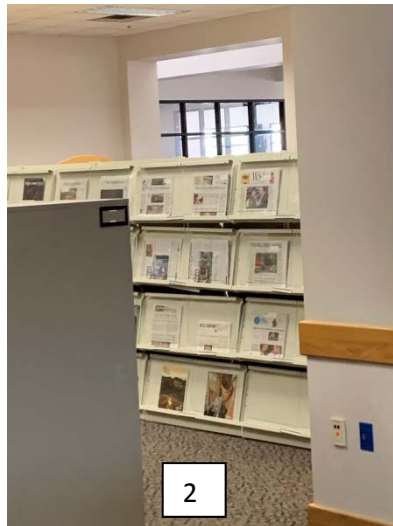
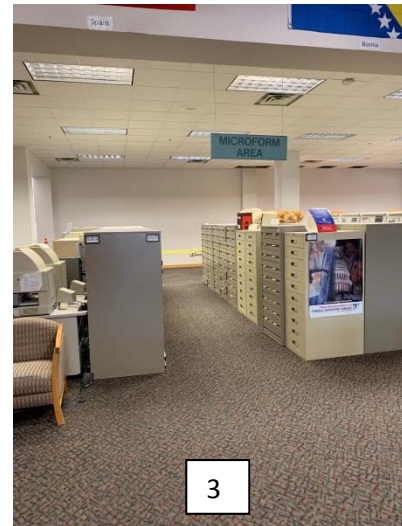
Interior: Carpet in foyer is blistering and will be a trip hazard until replaced (Photo1). The top row of the periodicals section shouldn't be higher than 48 inches and if it is, there should be a sign indicating that you can ask for assistance to reach higher placed materials (Photo 2). The checkout counters, at the microfilm areas, reference and help desks are higher than the 36” requirement (Photo 3).
