STATE OF NEW MEXICO
GOVERNOR'S COMMISSION ON DISABILITY

ACCESSIBLE BARRIER REPORT

WESTERN
NEW MEXICO UNIVERSITY

Inspection Date: 04/19/2019

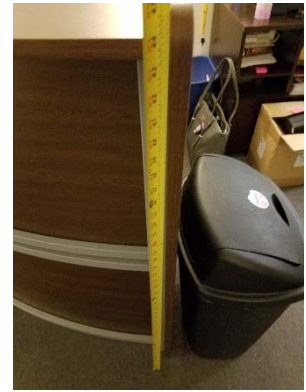
(21)

Student Services, Team Study and Concession Area – (21 & 22) The reception counter height is too high at 44" A.F.F. and does not provide access to a person in a wheelchair. The counter would need to be modified to provide a section 36" high maximum and 36" wide minimum. Also identified in (23-27) are further examples of non-compliant door hardware, furnishings encroaching on door clearances, dangerous protruding objects and non-compliant door clearances. Public restrooms (28-30) are multi occupant and should comply with technical requirements in Chapter 6 of the ICC A117.1-2009. Items identified as non compliant are: No wheel chair compartments provided with appropriate grab bars and clearances, urinal is mounted above 17" max to rim (measured at 19"), door clearances conflict with requirements of Figure 404.3.2.1, men's room lav height is above required 34" (measured 36"), paper towel dispenser encroaches on lav clearance and no insulation on pipes below lavs. There are no fire alarm devices located in restrooms.

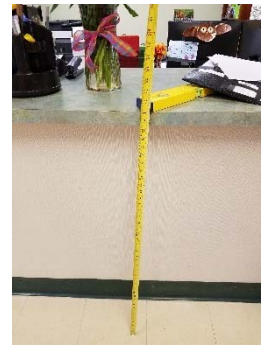
Interior Barriers – (3) The reception counter height is too high at 41" A.F.F. and does not provide access to a person in a wheelchair. The counter would need to be modified to provide a section 36" high maximum and 36" wide minimum. **(4)** Fire alarm pull stations and **(5)** door clearances (see Figure 404.3.2.1) should be maintained by removing furnishings. **(6)** Accessible signage should be removed where columns impede door clearances. **(7)** Interior ramp does not provide 12" extensions at ramp handrails. **(8)** Drinking fountains encroach on clearances required for location of door signs.

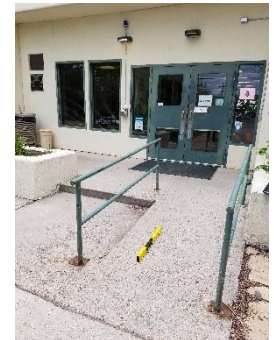
Exterior Accessible Route (2) - The cross slope of the accessible route is greater than 2.08%, and the ramp does not provide compliant edge protection or handrail extensions at the top and bottom of the ramp.

Entry (2) - The secured doors provide access through the use of a doorbell that is mounted at 57" (which exceeds the 48" maximum reach range).

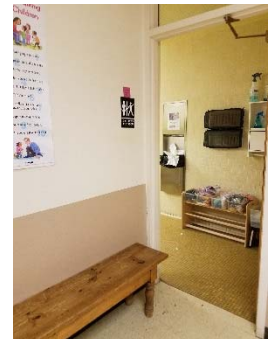
Interior Barriers – (4) and **(5)** door clearances should be maintained by removing furnishings (see Figure 404.3.2.1).

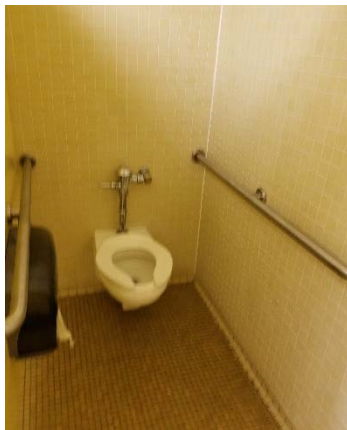
(8)

Bathrooms - All restrooms should comply with technical requirements contained in Chapter 6 of the ICC A117.1-2009. **(6)** Mirrors are mounted at 44" to the reflective surface above the finished floor (AFF) (which exceeds the 40" max. requirement for adults, 28" for Pre-K, and 37" for K-6th grade). The Lavatories are mounted 32 1/2" to the rim (although okay for adults, exceeds the 22" max. height for Pre-K, and 31" for K-6th grade), **(7)** The urinal is mounted 23" AFF (which exceeds the 17" maximum requirement for adults, and 14" maximum requirement for children), **(8)** No wheelchair compartment provided with a 60" turning circle.

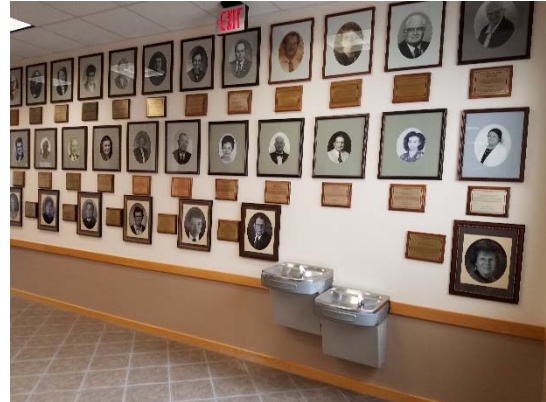
(1)

Interior Barriers – (1 & 2) Drinking fountains (D/F) serve as protruding objects, and do not provide protection for cane detection of people with site impairments (provide cane detection protection at all D/F). **(3)** Various doorways into rooms do not provide required door clearance per Figure 404.3.2.1. Handrail extensions at stairs are not compliant with Figures 505.10.1 & 505.10.2. Interior passage doors with closers require force in excess of 5# to open (10# -13# measured).

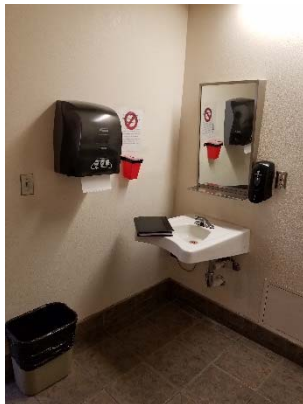
(5)

Bathrooms (4 & 5) - All restrooms (single and multi occupant) should comply with technical requirements in Chapter 6 of the ICC A117.1-2009, figures 604.2-606.3 attached to end of this report are included for easy reference. Items identified as non compliant are: no wheel chair compartments provided in multi occupant rooms with appropriate grab bars and clearances, urinals mounted higher than 17" max to rim, door size does not meet 32" requirement (measured 29"), some door clearances conflict with requirements of Figure 404.3.2.1, reflective surface of mirrors is higher than 40" max requirement for accessible lav, faucet controls require grasping and twisting of the wrist, shelf protrudes into accessible route as well as pipes are not insulated below lavs. Single occupant toilet rooms located on both floors required force in excess of 5# to operate the doors (12# & 13# measured), the mirrors are mounted in excess of 40" A.F.F. and the toilet centerline exceeds the code required range of 16"-18" from the adjacent wall per Figure 604.2 attached (18.5" & 19.5" measured). Pipes are also not insulated below lavs in single occupant restrooms.

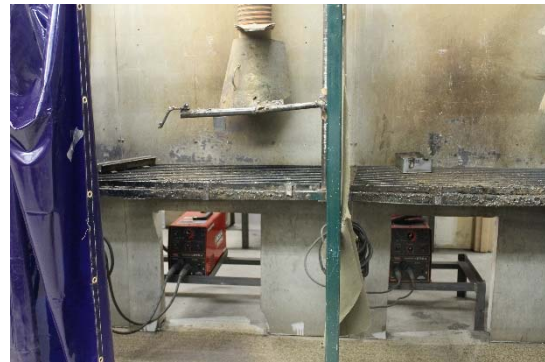
(3)

Technical Center Barriers (3 & 4) – The Construction Technical Shop and the Electrical Shop work tables are not accessible, and should be modified or replaced to provide a section 34" high maximum and 36" wide minimum. The welding shop provides no accessible welding booth work stations (a minimum of 1 of each type of welding process must provide a section 34" high maximum and 36" wide minimum).

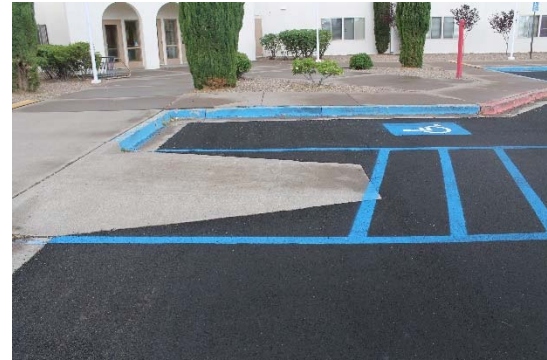
(1)

Parking (1 & 2) – The designated accessible parking is near the main entrance; however, the existing slope of the within the access aisle exceeds 2.08% maximum slope in any direction (because of the curb ramp protruding into the aisle). This requires removal of the existing curb ramp, re-paving/stripping of the access aisle, and new modification to the concrete to provide new access to the sidewalk (we suggest a parallel curb ramp that provides a 60” wide minimum landing at the same level as the access aisle and the entire width of the sidewalk, which then ramps up in both directions to maintain the continuity and accessibility of the walk. There is also only one sign serving two accessible parking spaces. Signage should be provided per requirements of Figure 1 and Figure 2 (see attached), and one accessible parking space min. shall be designated for vans.

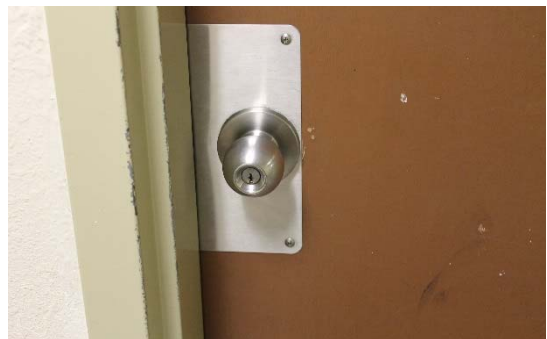
(4)

Entry (3 - 6) - Hardware varies from non-compliant (requiring tight grasping, pinching or twisting of wrist) to compliant, but the door with the compliant hardware is not identified as the accessible entrance. Provide ISA at designated door or make all doors compliant with proper hardware and other requirements.

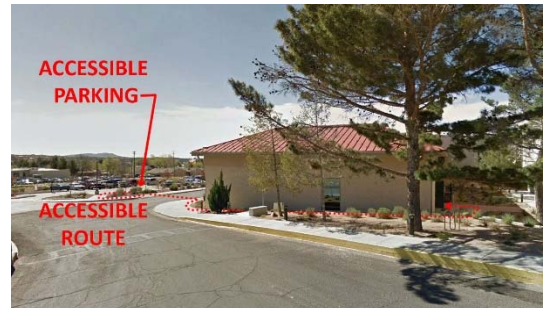
Parking (1) – The designated accessible parking appears compliant but is not located near the accessible entrance and should be verified to meet all the requirements of Figure 1 and Figure 2 attached.

Exterior Accessible Route (1) - The path of travel to the entry doors is accessible, except for providing directional signage and a pedestrian crosswalk should be identified with pavement markings where it crosses a vehicular street to access the building.

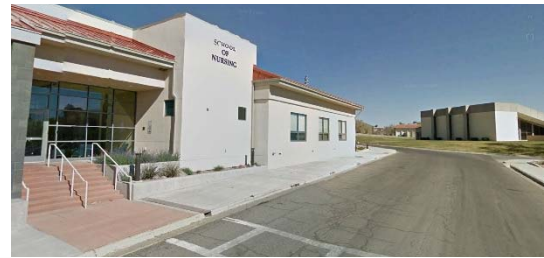
Entry (2) - The accessible entrance is around the rear of the building, because the main entrance is limited to stairs. The GCD suggests providing a ramp with the required switchbacks to allow entry into the main entrance instead of the requirement to circumnavigate the entire building in a wheelchair. A ramp should be provided per the requirements of Section 405 of the ICC A117.1-2009 and the Figures 405.7 - 405.9.2 attached for convenience.

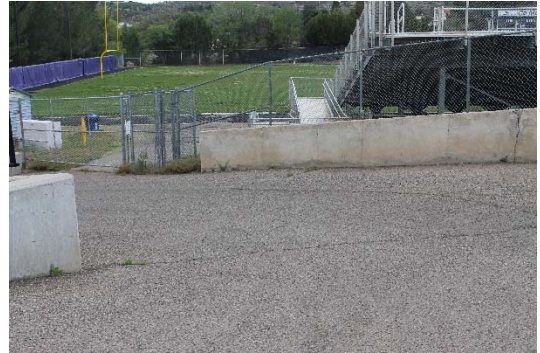
(1)

Parking – The designated accessible parking appears compliant but does not provide the required signage per Figure 2 (attached) and the pavement markings for the access aisle do not include the ‘NO PARKING’ requirement of Figure 1 (attached). New striping should be incorporated to meet all the requirements of Figure 1 and signage requirements per Figure 2 attached.

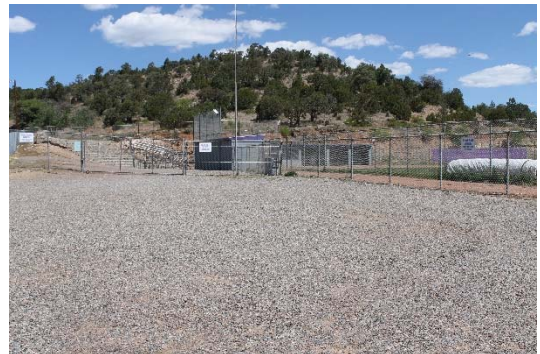
Parking (1) – The parking lot is a gravel surface with no accessible parking provided and should be modified to meet all the requirements of Figure 1 and Figure 2 attached for the required accessible space(s) to include a firm, stable slip resistant surface.

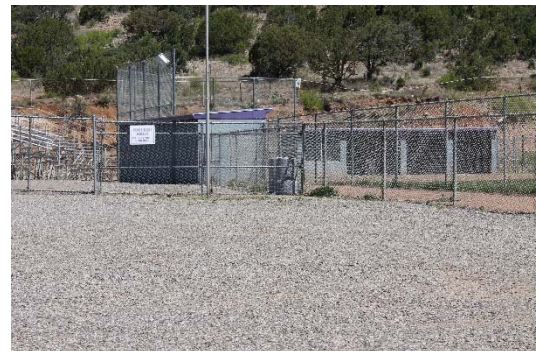
Exterior Accessible Route (2) – There is no accessible path of travel to the spectator seating or to the dugouts. A firm, stable and slip resistant surface should be provided to these areas from the accessible parking that meets the requirements of 3 and 4 of the ICC A117.1-2009.

Barriers – The spectator seating did not provide accessibility for wheelchair seating nor companion seating. No concessions or restrooms for spectators were identified in this survey. If concessions are provided, they must be accessible, and if portable restrooms are provided for events, at least one must be of the accessible type.

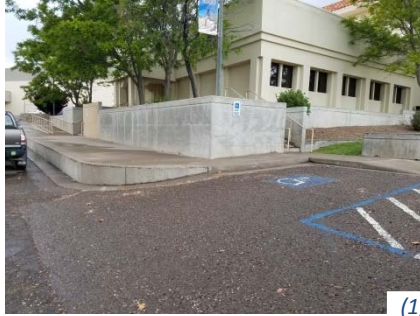
Parking – Accessible parking is provided. The off-street designated accessible parking is close to the main entrance; however, the International Symbol of Accessibility needs to be repainted and the required “NO PARKING” text, at the foot of the access isle, is not provided (See **SIGNAGE** requirements at end of report). One accessible parking space should be designated as “Van Accessible”.

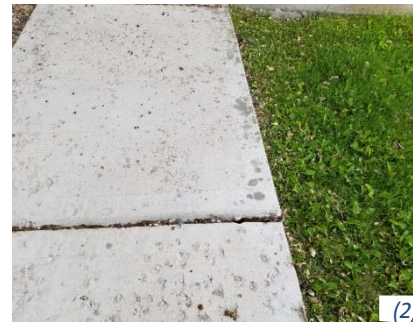
Exterior Accessible Route – A firm, stable, consistent surface is required, clear of vegetation. Photo (2) shows an instance where there is a 1/4” change in grade as well as a 1/4” gap along the path of the side walk, providing an irregular surface.

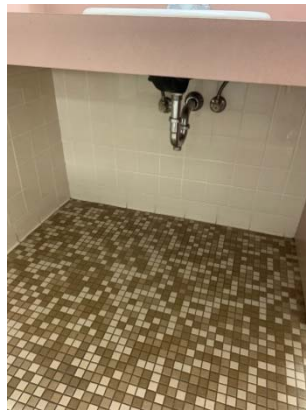
Bathrooms - All restrooms should comply with clearance and plumbing fixture requirements displayed in figures 604-608.4.3 at end of this report. Protection against contact with drain pipes and supply lines under lavatory is required. Photo (3) shows no insulation provided on the drain pipe.

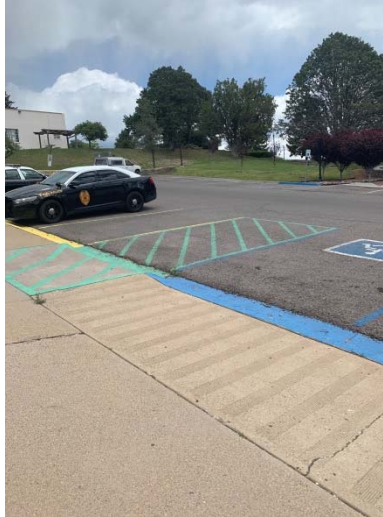
(1)

Parking– Accessible parking is provided. The off-street designated accessible parking is close to the main entrance; however, the cross slope exceeds the maximum allowable 2%, and will prove difficult for a person utilizing a wheelchair (Photo 1). Also, the International Symbol of Accessibility needs to be repainted. The required “NO PARKING” text at the foot of the access aisle is not provided. The access aisle should be painted in blue, currently green. (See **SIGNAGE** requirements at end of report). One accessible parking space should be designated “VAN ACCESSIBLE” with required signage (Photo 1).

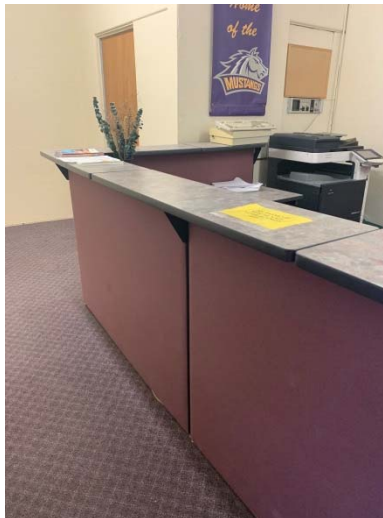
(2)

Interior Barriers – The reception counter height is too high at 43” A.F.F. This does not provide access to a person seated in a wheelchair. A portion of the counter needs to be lowered to provide an accessible work surface of 34” high maximum and 36” wide minimum (Photo 2).

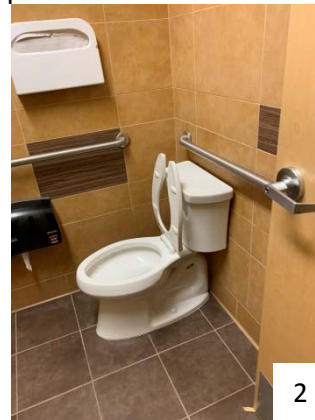
Downstairs: The flush lever is located on the side closest to the wall in the men’s restroom. Flush lever should be located on the open, transfer side (Photo 2). All restrooms should comply with clearance and plumbing fixture requirements displayed in figures 604-608.4.3 at end of this report. Protection against contact to drain pipes and supply lines under lavatory is also required.

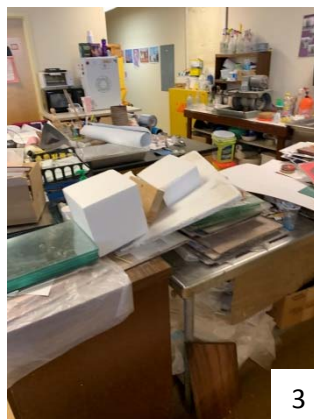
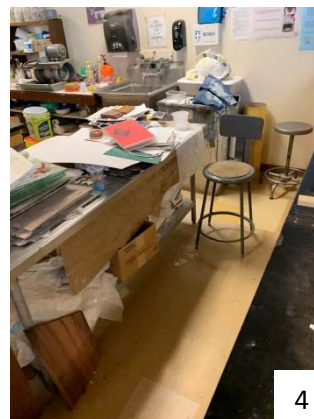
Interior Barriers – The required 36” accessible route is not provided in the 3D Studio (Room 111). Tables must be spaced as such that a path of travel a minimum of 36” in width is provided to at least one of each type of the different elements provided. (Photo 3 & 4).

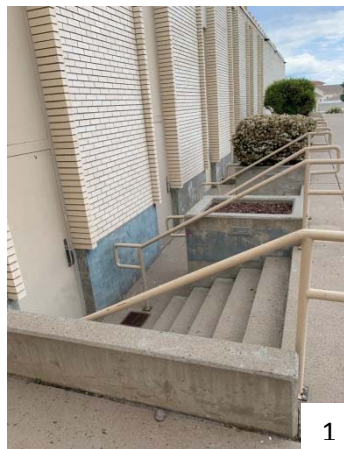
Means of egress: Interior directional signage is required to show where the exits are located on each side of the theater’s isles. While the theater provides twelve, both emergency and non-emergency, exists in addition to the main entrance, none of these exits (six on each side of the theater) provide compliant exiting with a path of travel to exit and get away from the building, for a person using a wheel chair (Photo1).

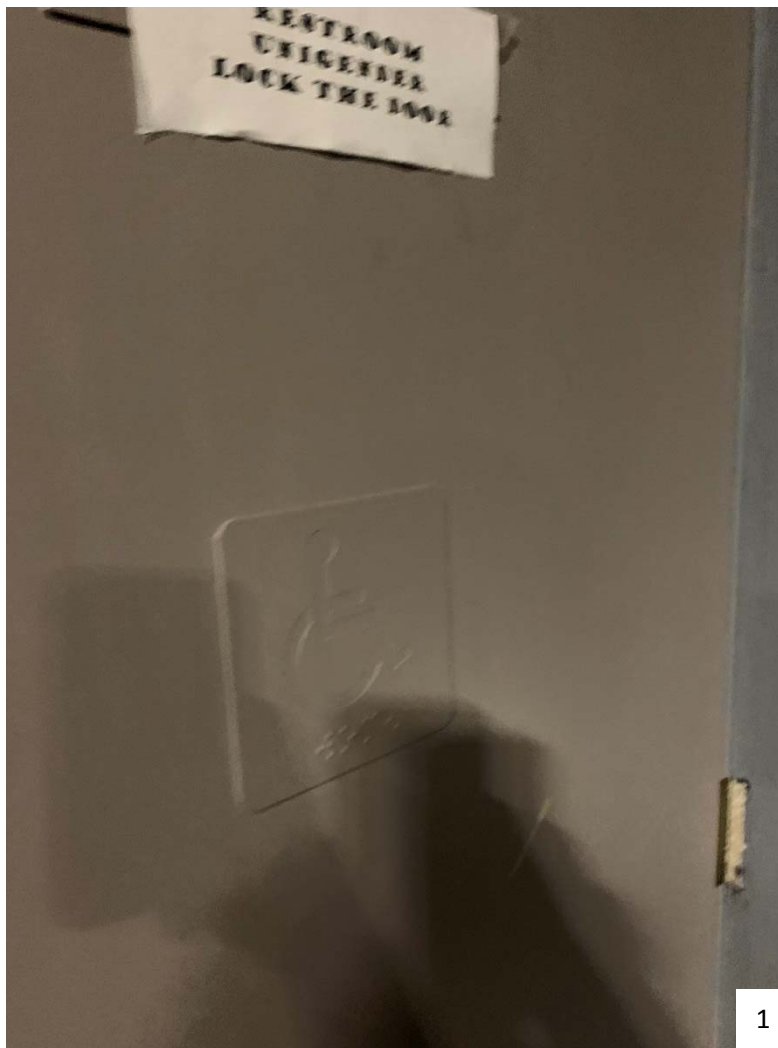
Bathrooms - All restrooms should comply with clearance and plumbing fixture requirements displayed in figures 604-608.4.3 at end of this report. Door signage reflecting the International Symbol of Accessibility needs to be visible, it has been painted over, the same color as the door (Photo 1). Refer to Figure 703.3.10 at the end of this document for location requirements.

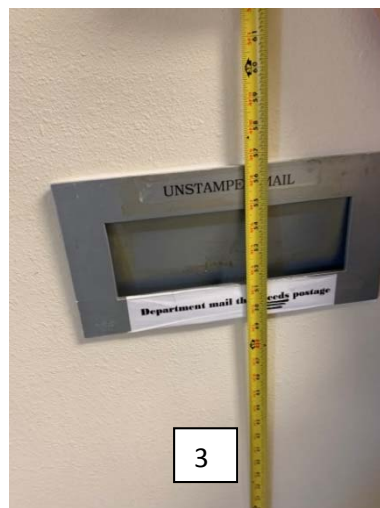
Post Office: The unstamped mail drop-off collection box exceeds the 48” maximum reach range requirement (Photo 3).

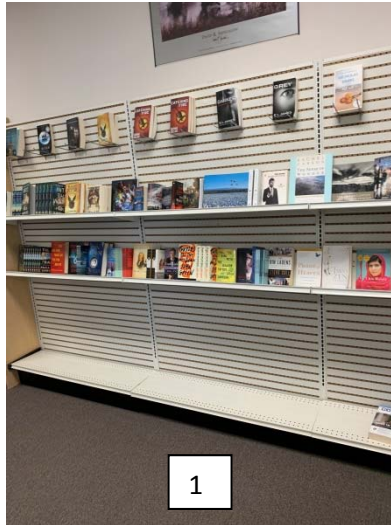
Book Store: Provide signage indicating that assistance is provided by staff for any items that are shelved above the 48” maximum reach range (Photo 1).

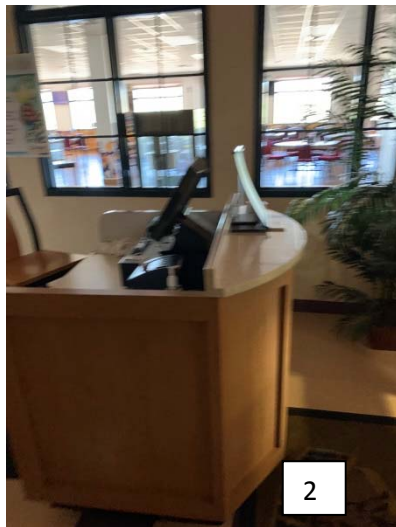
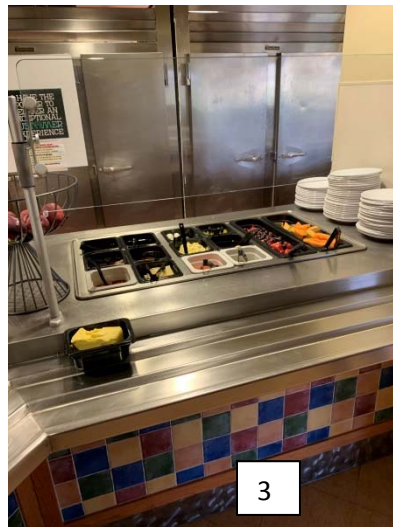
Cafeteria - The area where students scan their card for payment needs to be lowered to where the operable part is lower than 48” (Photo 2). The counters for self-serve items cannot be higher than 36 inches above the floor. Food service items are placed toward the back of the serving counter beyond the maximum depth for a reach range of 10”-24” (Photo 3). While this leaves space for people to set their trays, plates, or beverage containers, this may make items more difficult to reach. Condiments also do not meet this requirement (Photo 4). The operable parts in the coffee and beverage area exceed the maximum 48” high requirement. The operable parts on the coffee and beverage machines are 53” high.
